Fisher Body

1969 FISHER BODY SERVICE MANUAL

**FOR ALL
BODY STYLES**

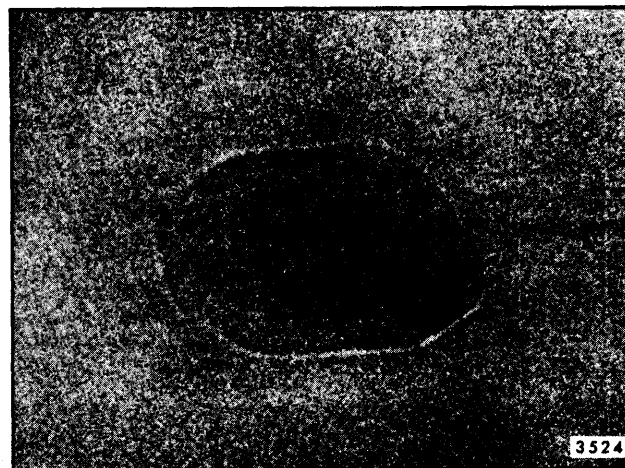
Fig. 1-12—Bull's-Eye

A spotted, ringed, outline or low area in the color coat. It often gives the illusion of a different color, depending upon the peculiarities of light and shadows in the area. Primer might show.

Cause: A bull's-eye is the result of undercoat shrinkage; incomplete spot repair; or poor technique.

Correction: In minor cases, sand with No. 600 sandpaper and polish. In extreme cases, sand and featheredge the area correctly, build up the paint surface with undercoat, then color coat as required.

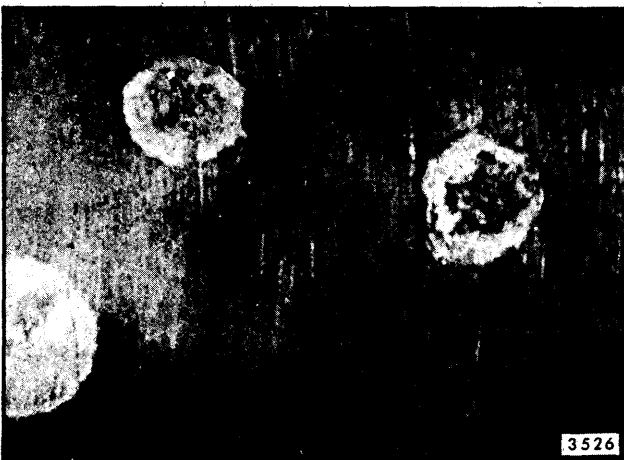
Fig. 1-14—Chemical Discoloration

This is a condition that can occur on solid or metallic colors and is evidenced by contrasting color spots appearing mostly on flat or horizontal surfaces. On red metallics, the spots are darker red;

on blue metallics, the spots are darker blue; etc. On solid colors, the discoloration spots may be of any color depending upon specific conditions.

Cause: On metallic colors the condition apparently is caused by fall-out or moisture in the form of rain water containing acid or alkaline materials which attack the aluminum flake. On solid colors, specific pigments may be affected by specific materials from fall-out.

Correction: In mild cases, rub out and polish. In severe cases, sand to remove the condition and color coat as required. The best prevention against this condition is to keep the paint finish clean and polished.
